## Good Practice Working Group: Low Frequency Footfall Noise Problem

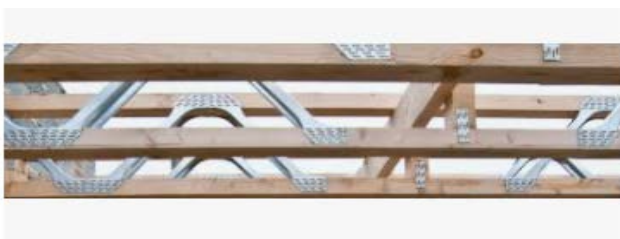
Anecdotal evidence indicates that the problem is most prevalent in lightweight (i.e. timber) floors due to the lack of adequate stiffness. The constant drive to reduce costs is only exacerbating the problem, as any value engineering usually results in lower stiffness (e.g. due to thinner materials, wider spacing of joists, etc). It has also been suggested that open web timber joists are seemingly "up there" as one of the worst offending components:
