## Low Frequency Footfall Noise Problem

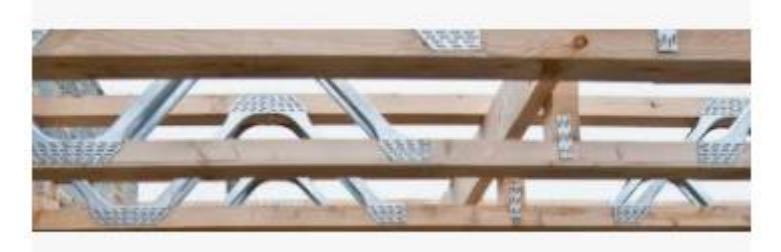
Anecdotal evidence indicates that the problem is most prevalent in lightweight (i.e. timber) floors due to the lack of adequate stiffness. The constant drive to reduce costs is only exacerbating the problem, as any value engineering usually results in lower stiffness (e.g. due to thinner materials, wider spacing of joists, etc). It has also been suggested that open

web timber joists are seemingly "up there" as one of the worst offending components:
